**BUCHER**  
emhart glass

**Glass container defects**  
Causes & remedies

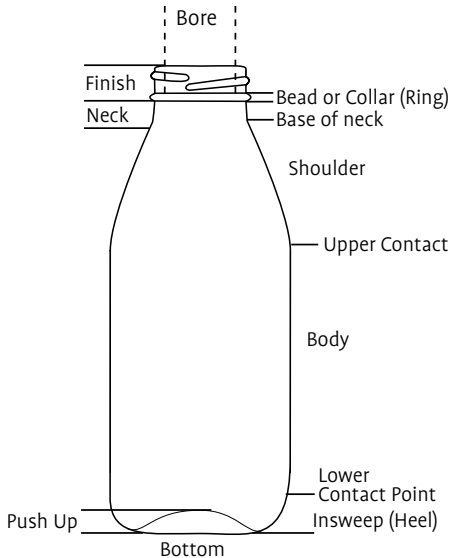
## The various parts of a container

**Finish** This is the top of the container above the neck ring parting line.

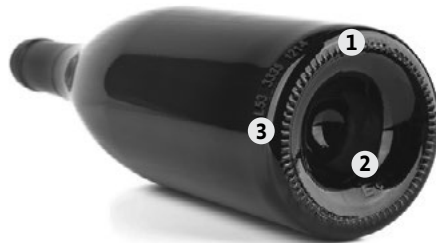
Punt marks are used by glass manufacturers to identify their containers. You can learn about containers by reading these punt marks.

- 1 Cavity Identification** The bumps on the heel and/or rings on the bottom enable inspection equipment to read the bottle information
- 2 Manufacturer's mark**
- 3 Additional information** may include plant identification, year manufactured, mold number, container capacity and fill level
